Manhole Inspection Summary

Manhole # S29KK_049MH

Insp Date: **7/16/07 11:36 AM**

Location Address: **1934 MOUNT ROYAL TERR**

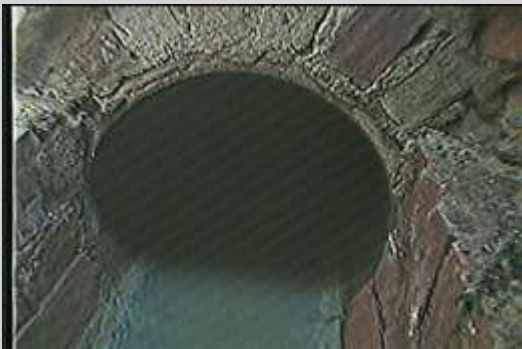
12 in. Circular Gravity Sewer Pipe In @ 7 O'Clock

Pipe Material: **Clay** ☐ Pipe Lined

Infiltration: **None** Pipe Seal Cond: **Unknown**
